# Grand Canal, Dublin

Contractor—Fressinet/ Norfolk Marine

Owner—Waterways Ireland

The stonework gravity walls to the historic dock basin were suffering from face failure underwater due to loss of its original weak lime mortar. An underwater concrete face repair was selected as the repair method, nominally 100 mm thick. A 10 m long mesh control frame system was adopted which carried a fabric formwork face shutter connected to base and leading side grout bag seals.

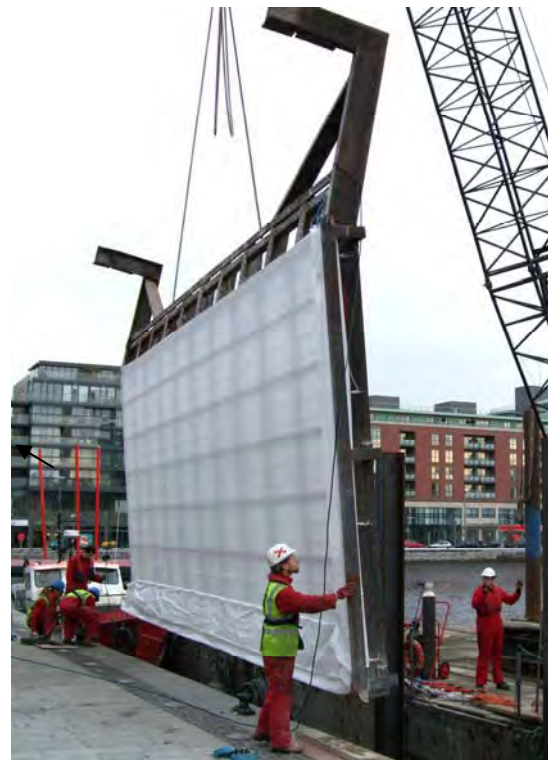
**Control Frame Being Craned into Position**

The frame was temporarily supported by driven piles with rams to the bottom and drilled anchor ties to the top. The shutter system was filled with a sand: cement micro concrete. The bleed combination of the micro concrete mix and fabric face formwork quickly reduces concrete filling pressures and allows a lower weight frame system to be used. It also produced a good quality concrete face repair which also infilled failed stonework areas.

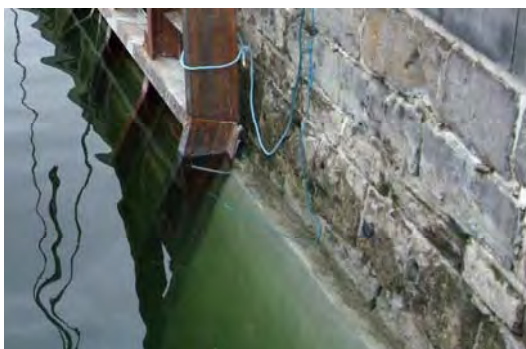
**Top of Concrete Wall Repair**
