Marine Pile Repairs by Concrete Encasement

Martin Hawkswood, Proserve Limited, Kenilworth, UK

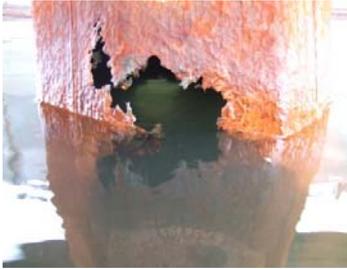
Fig. 1 – ALWC Damage

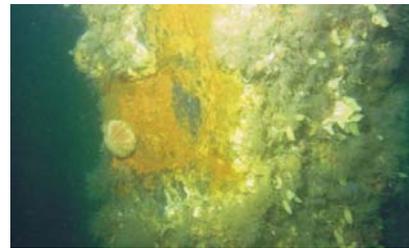
Fig. 4 - ALWC

“Although unclassified, varying rates of corrosion by ALWC up to 4 mm/ side/ year have been recently reported and cases in the order of around 1mm/ side/ year appear to be common.”

The concentrated corrosion risk from ALWC is acknowledged to be much higher although quite variable. The ‘Briefing Sheet’ and the ‘Port Designers Handbook’ outline the expected causes of ALWC. It typically displays a bright orange corrosion product and typically peak corrosion occurs at and just above the low water zone (LAT). Occasionally the section loss is significant throughout the water depth. The Lerwick case history demonstrated that ALWC was significant at bed level and in the immersion zone as well as at low water.

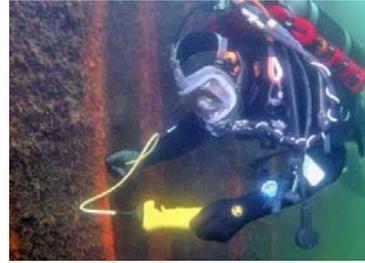
This threat can be managed by visually checking for the development of ALWC and steel thickness monitoring using suitable measuring instruments. This can be conducted quite simply and cost effectively from a boat at low water and above. Reference should be made where possible to the original design and the corrosion thickness allowance, so that the section loss can be measured against this allowance.

Fig. 5 – Thickness Monitoring

When corrosion loss becomes significant relative to the design allowance, a full diver survey through the water column and up to the deck is advisable. Thickness readings should be at closer centres to areas of critical loss (usually to low water zone) and then adjusted to locate the areas of maximum section loss. H piles or Rendex piles (welded sheet pile sections, Lerwick & Dublin Port) should be checked on all flat elements due to differing corrosion performance. Extruded steel circular piles are normally checked on 4 sides to critical areas.

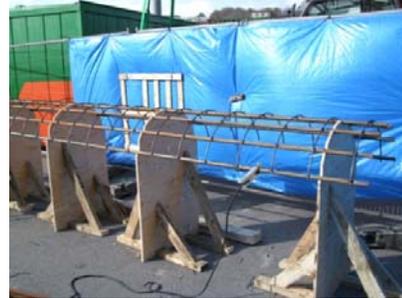
Where pile section loss is structural, the piles can be designed to be strengthened by reinforced concrete encasement. Where steel section loss is modest, it can simply be made up with reinforcement bars or similar. Where section loss is significant, it is more effective to design reinforcement using a composite steel and RC section basis. For ease of application, reinforcement is usually designed in 2 half cages which are accurately fabricated for relatively easy assembly round the pile with loose curved overlap links fixed by diver to link them together (Fig. 6).

Fig. 6 – Reinforcement Cage

Strengthening reinforcement within the concrete encasement can be designed as required to cover the defective pile length. As previously described, reinforcement cages should be designed in two accurately made halves which can be readily linked together by divers using curved links (Fig 6).

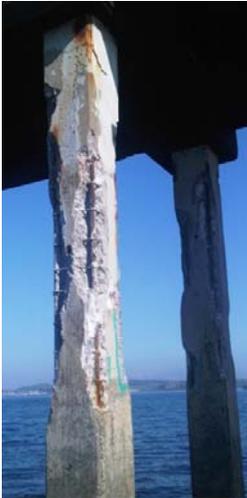
Damage to sections is normally caused by surface carbonation of the concrete with the penetration of chlorides (readily present in sea water) promoting rusting of the reinforcement and subsequent cracking and spalling of the concrete cover. Generally damage has occurred from just below low water (LAT) through the tidal zone and lessening into the splash zone. Reinforcement corrosion is not generally found in the continuous immersion zone.

Fig. 8 - Damaged
R.C. Pile,
Hunterston

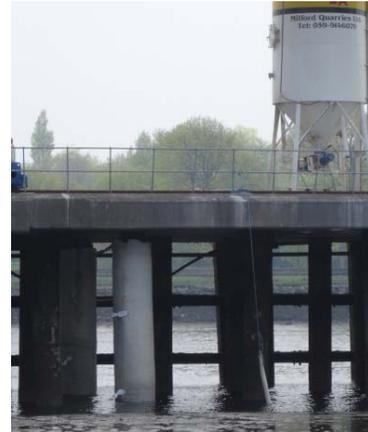
Fig. 24 – Pier & Silo

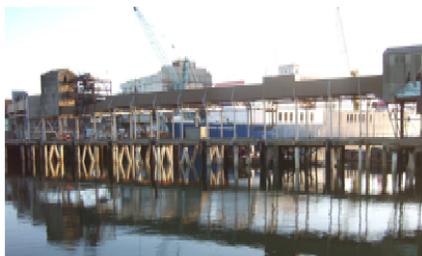
Fig. 25 – Bulk Jetty

The Bulk Jetty was built in 1950. The steel piles to the jetty were in such a poor condition with many piles holed through corrosion that the structure was considered for demolition (Fig 26).

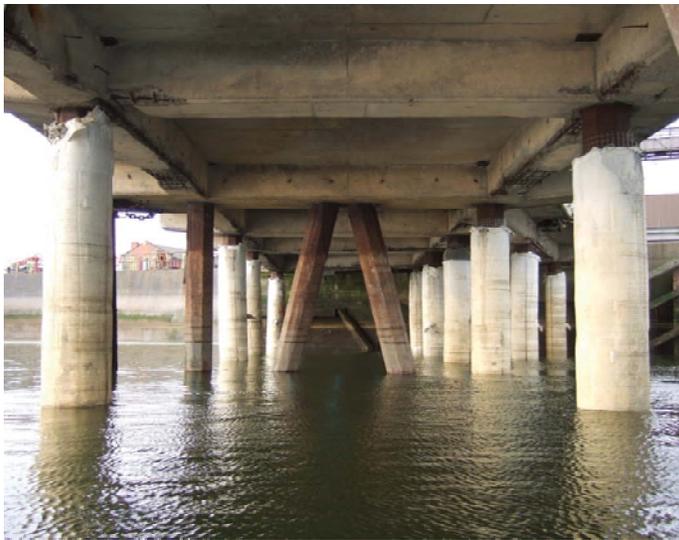
The steel piles were high pressure jet cleaned and inspected before the pile jacket system was applied. 138 piles were protected including raker piles. Pile encasement lengths were typically 9-11m long down to bed level. The top 0.3m of the pile was protected by sprayed concrete onto joint continuity mesh reinforcement. The work was completed in some 7 months, generally using 2 dive teams, putting the jetty back into working condition.

Fig. 27 – Jetty Pile Repairs
